**FIVE-YEAR REVIEW REPORT**  
**THIRD FIVE-YEAR REVIEW REPORT**  
**FOR**  
**UNIVERSITY OF MINNESOTA ROSEMOUNT RESEARCH CENTER SITE**  
**ROSEMOUNT**  
**DAKOTA COUNTY**  
**MINNESOTA**

**Prepared by:**  
**United States Environmental Protection Agency**  
**Region 5**  
**Chicago, Illinois**

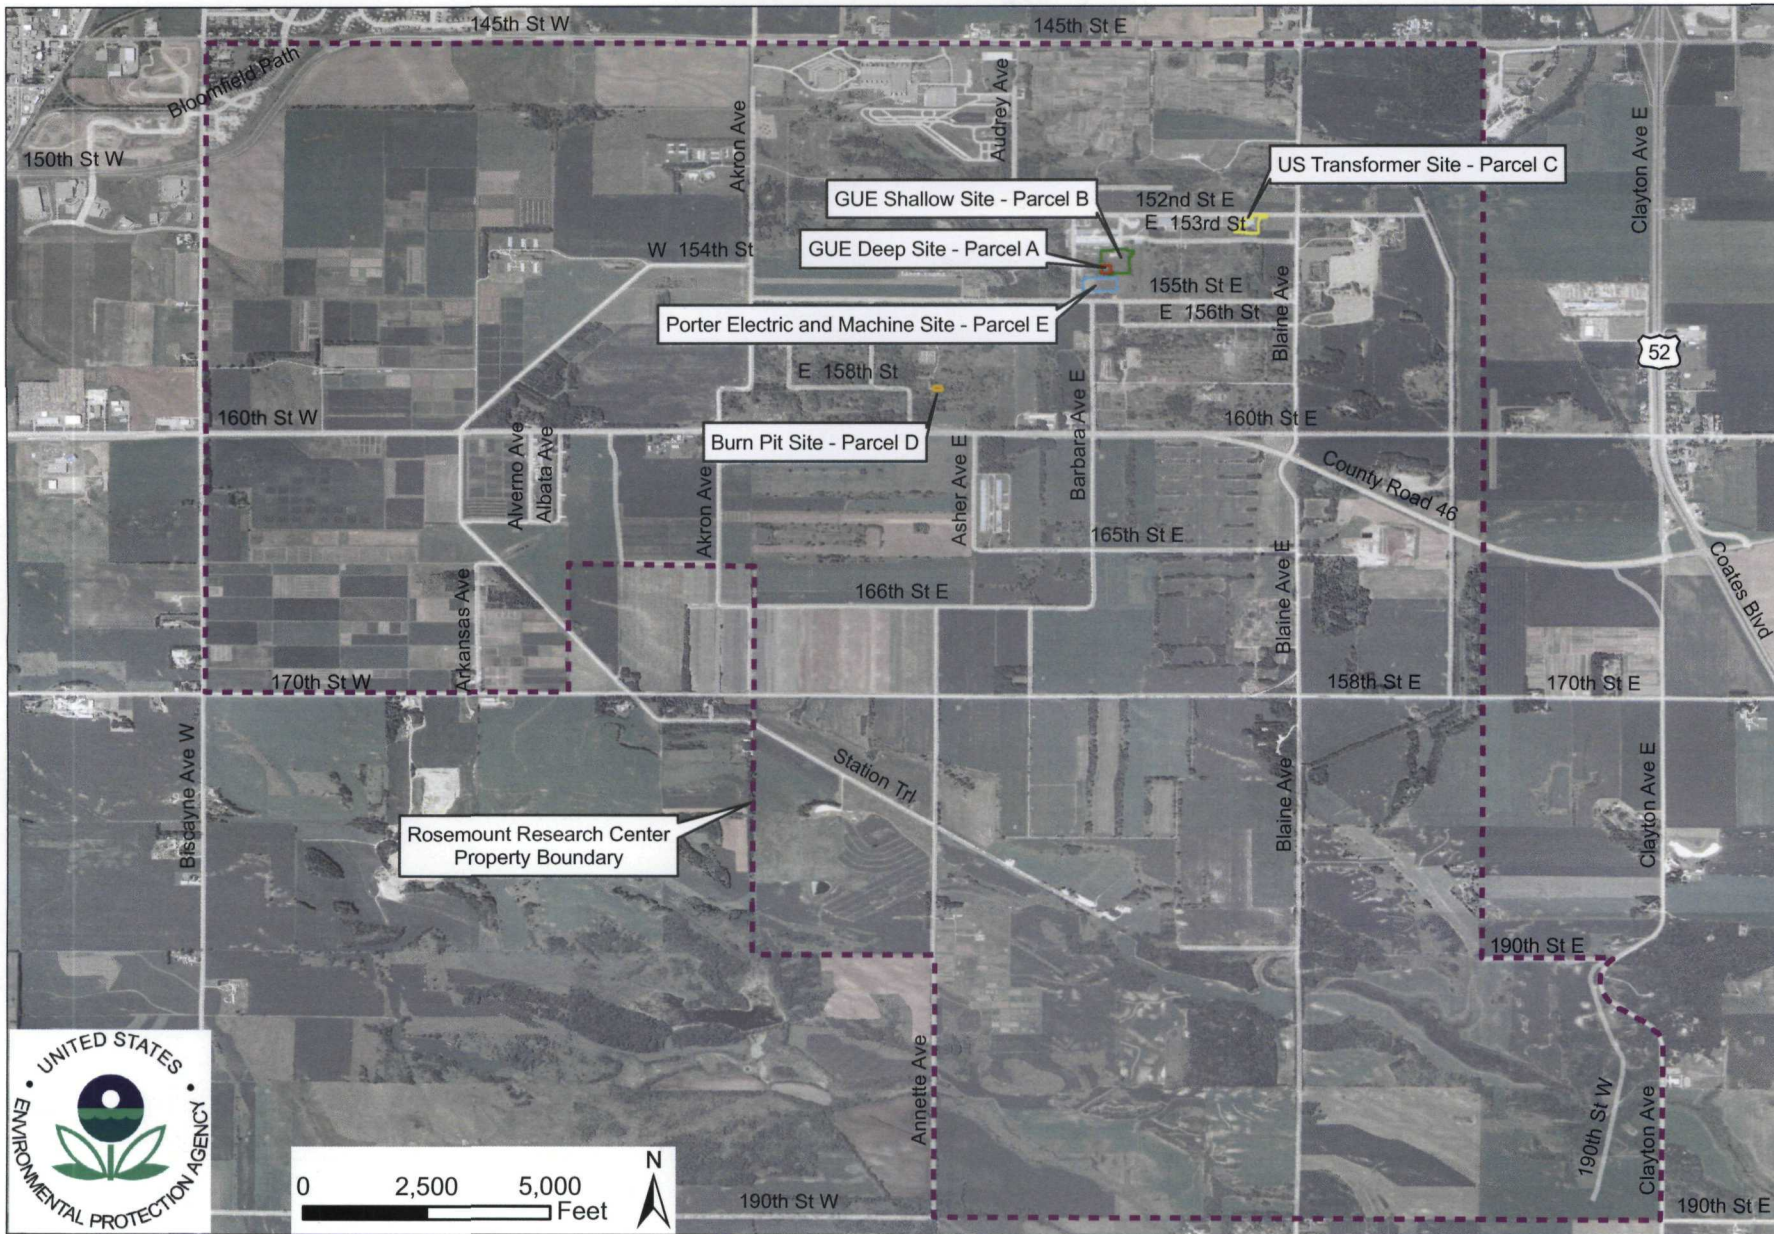
Figure 2

U.S. EPA prepared two GIS maps of the Site that illustrate areas of restricted use. See Figures 2 and 3 which are attached.
